Selective laser melting of Alloy 718

Influence of heat treatments on heat affected zone cracking of selective laser melted and TIG-welded Alloy 718

PhD Student: Tahira Raza

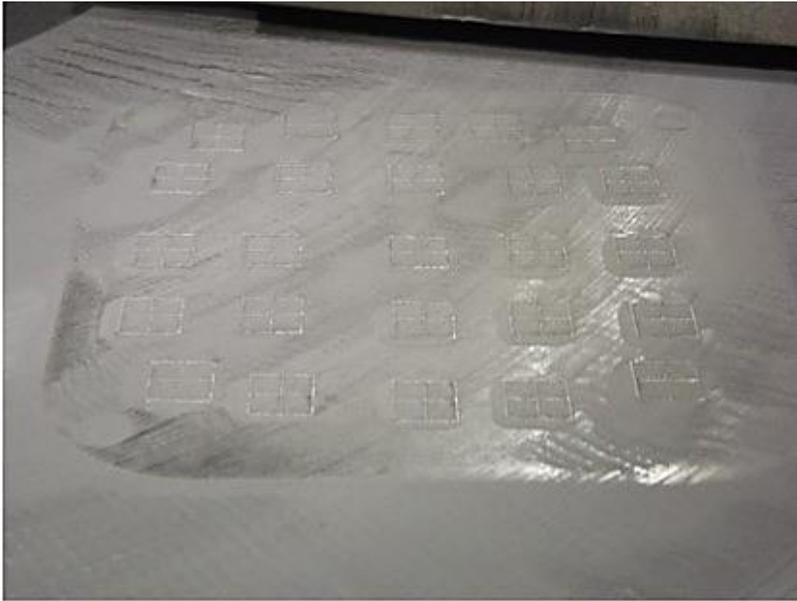
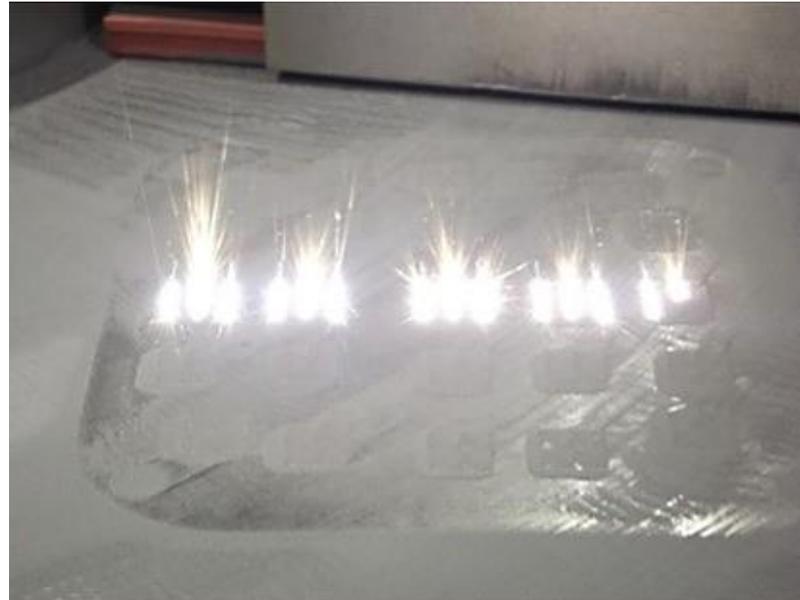
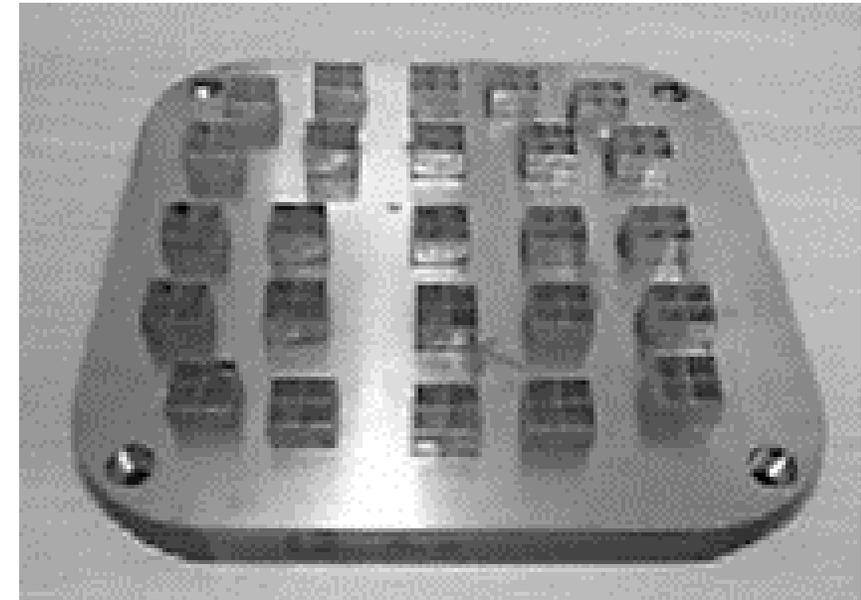
Selective laser melting process

SLM/ DMLS/ Laser Cusing: Additive manufacturing powder-bed process:
3D CAD data > Laser beam > Fuse metal powders > 3D metal parts

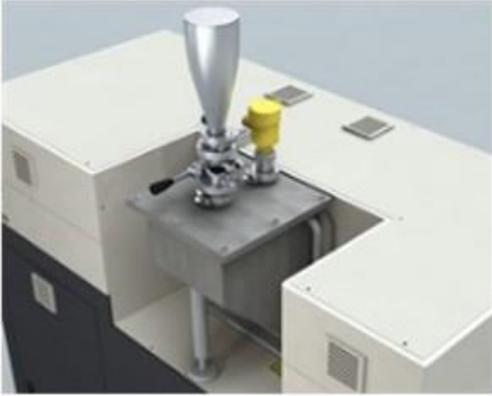
1. Loading powder

Loading metal powder before and during build.

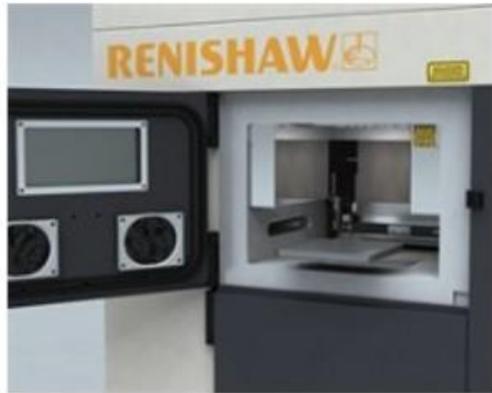
2. Build plate loaded

Build plate is loaded into the system chamber and secured.

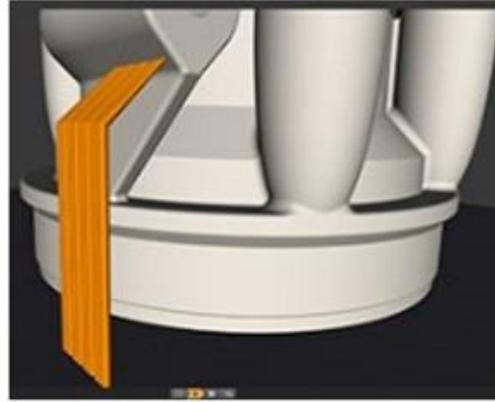
3. Build preparation

Offline build preparation file is exported to the additive manufacturing system.

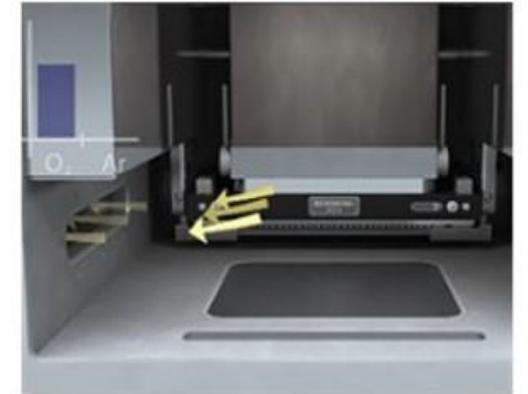
4. Remove air

Build chamber is prepared with vacuum removal of air.

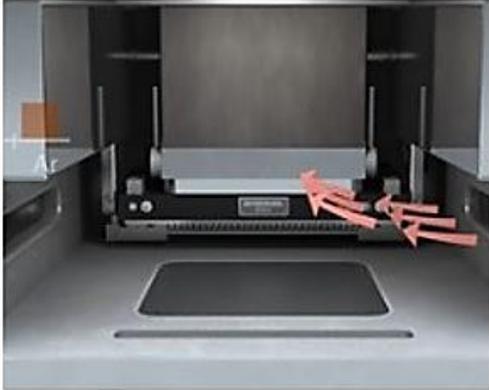
5. Inert gas

Chamber is filled with argon inert gas - class leading low gas consumption.

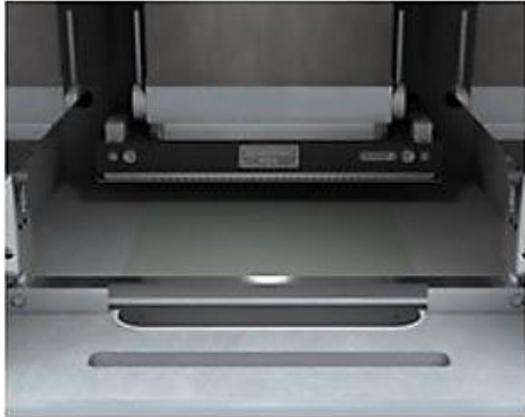
6. Powder delivery

Layer of metal powder is delivered.

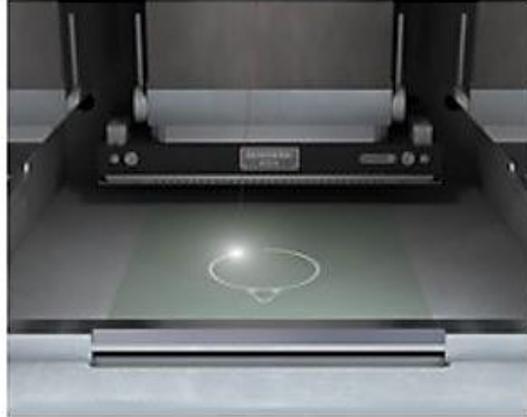
7. Laser melting

Laser melting using a fibre laser.

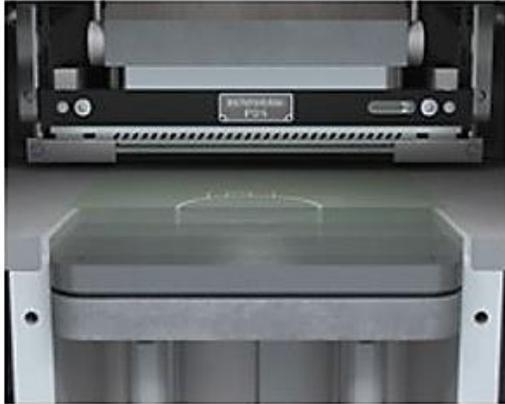
8. Building in layers

Build plate moves down and next layer is built up.

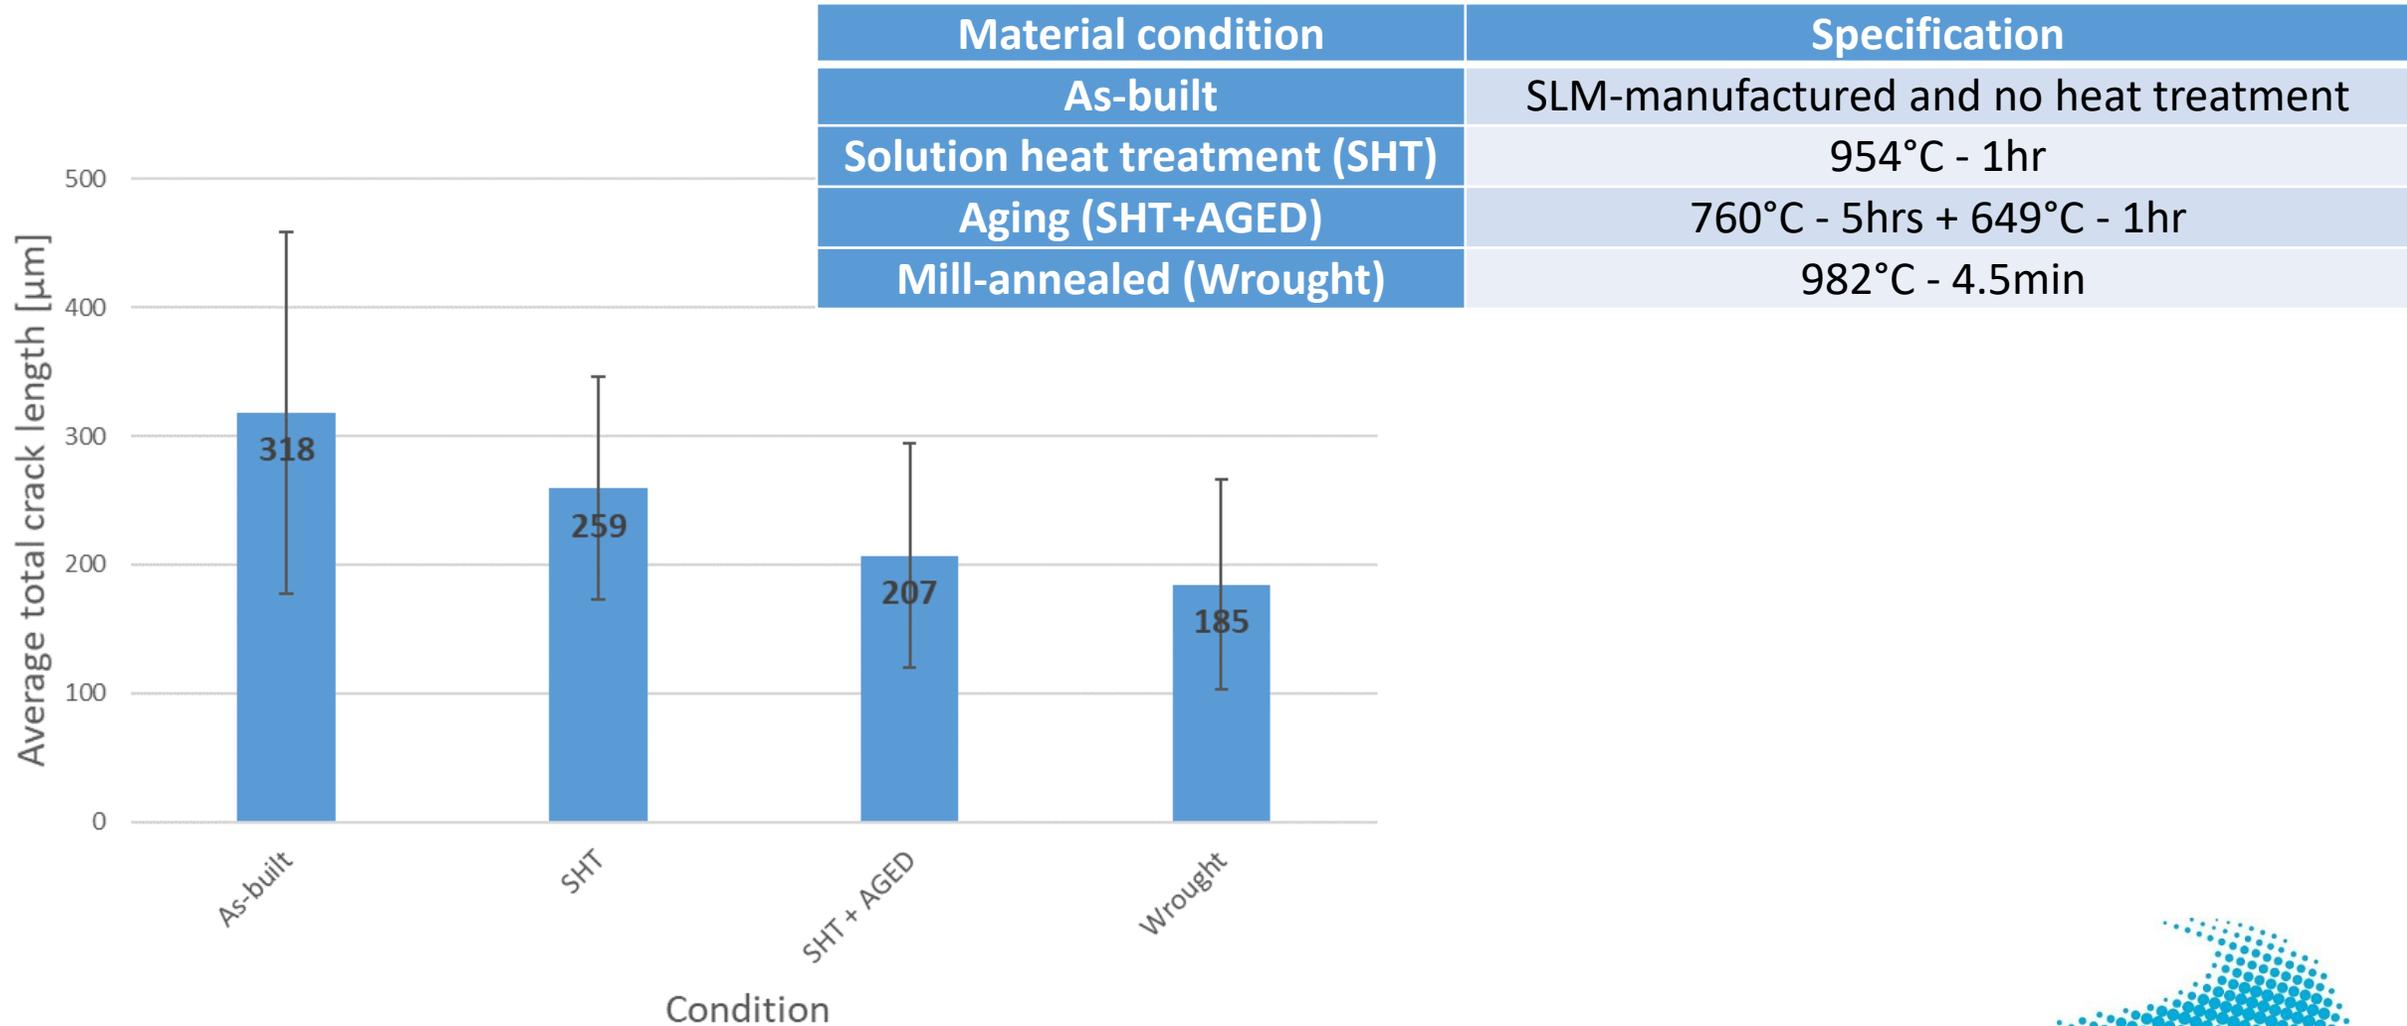
Total crack length measurements

Heat affected zone cracking susceptibility of SLM-manufactured Alloy 718

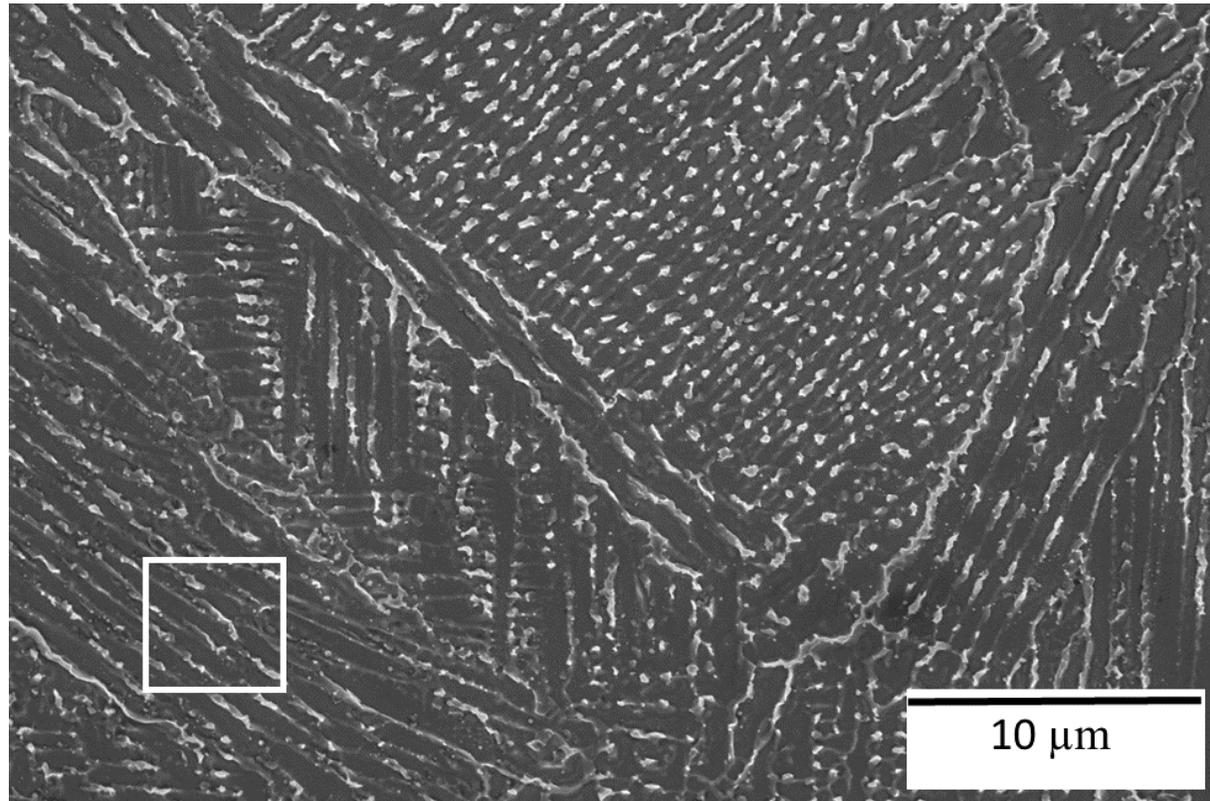
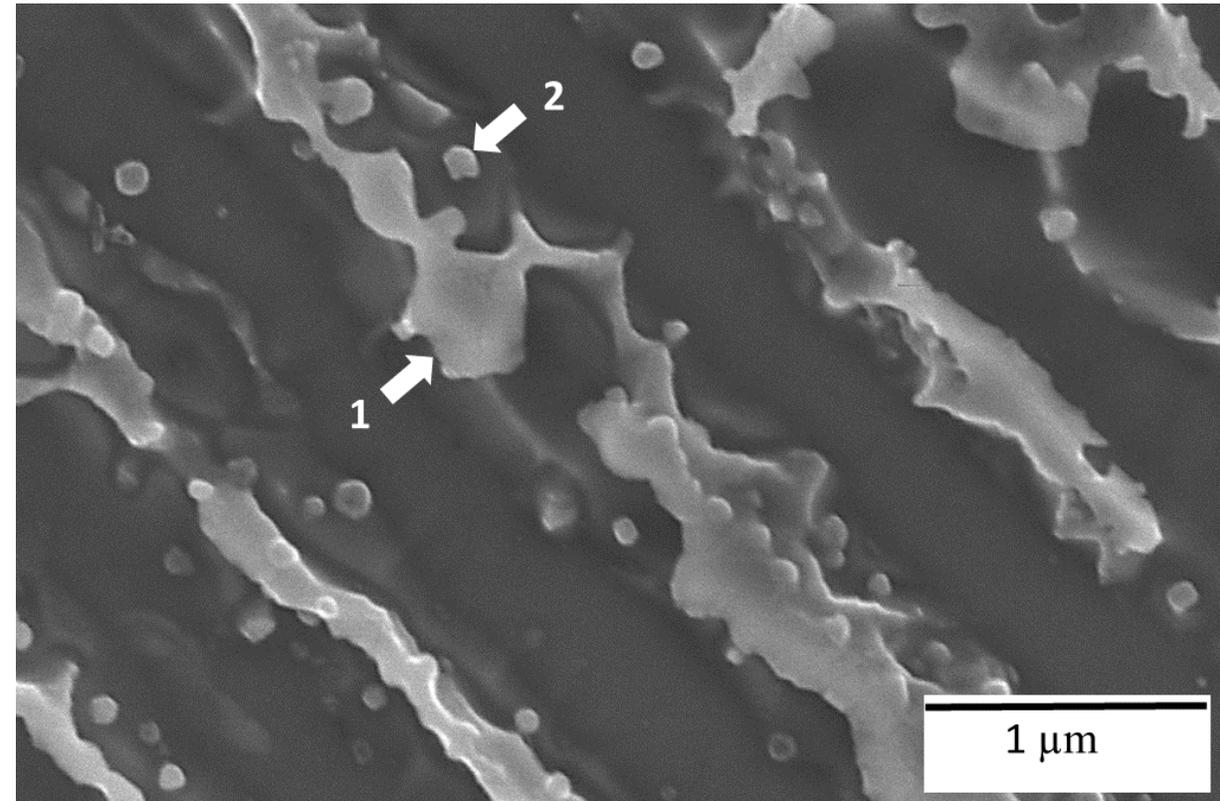
SLM As-built Alloy 718

Interdentritic regions in as-built condition showing (1) Laves phase and (2) MC-type carbide

- **As-built** Alloy 718 contained Laves phase and NbC carbides in interdendritic regions that caused the liquation of grain boundaries in HAZ during welding.
- After **solution heat treatment**, most of the Laves phase was dissolved and precipitation of delta phase occurred. The remnants of Laves phase along with NbC carbides were liquated and created cracks during welding process.
- After **solution + aging treatment**, the Laves phase was fully dissolved and extensive amount of delta phase was formed at grain boundaries. Additionally, NbC carbides, γ' and γ'' was also formed in the microstructure. Liquation of NbC carbides was the main cause of HAZ liquation cracking in this condition.
- After **SHT+AGED** heat treatment, the cracking susceptibility of SLM-manufactured Alloy 718 became almost similar to **wrought** Alloy 718.

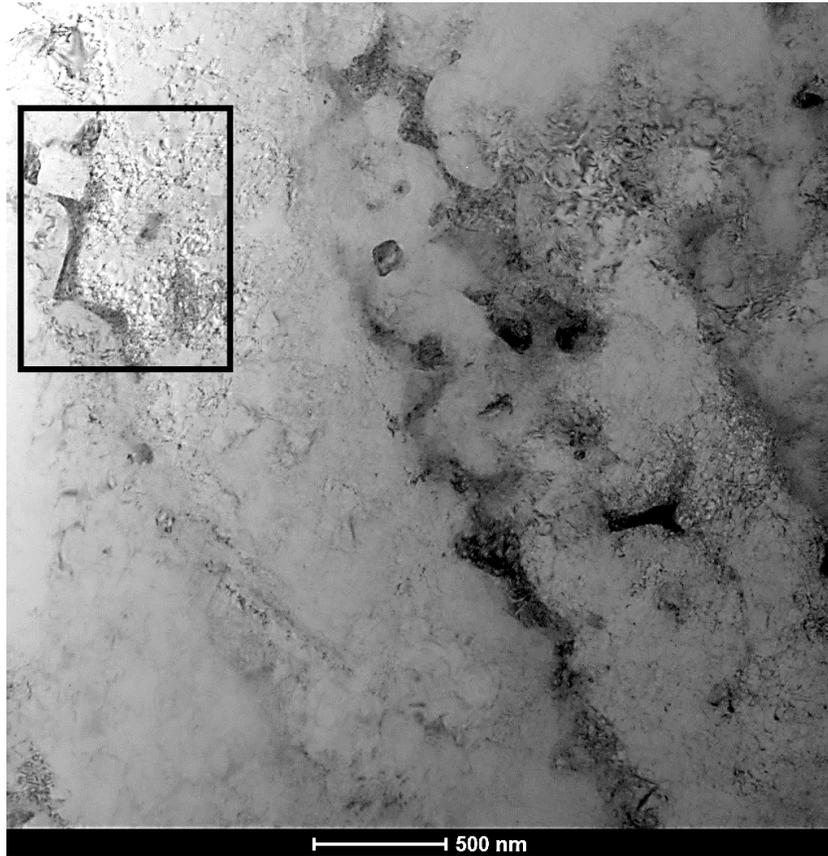
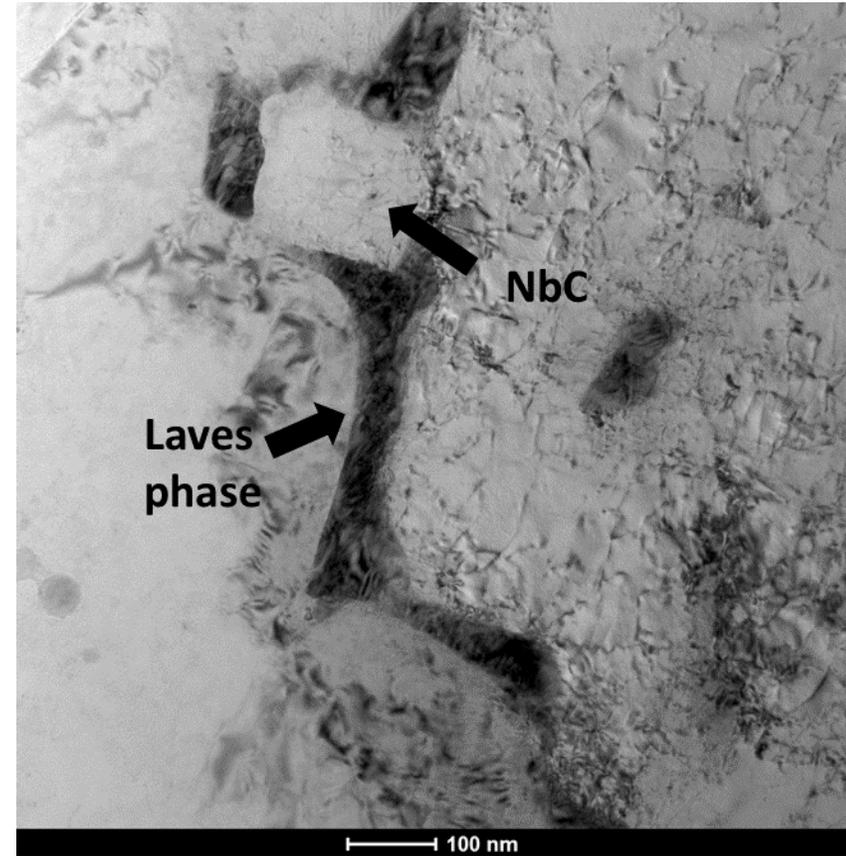
SLM As-built Alloy 718

TEM bright field image of Laves phase and NbC carbide in interdentritic regions

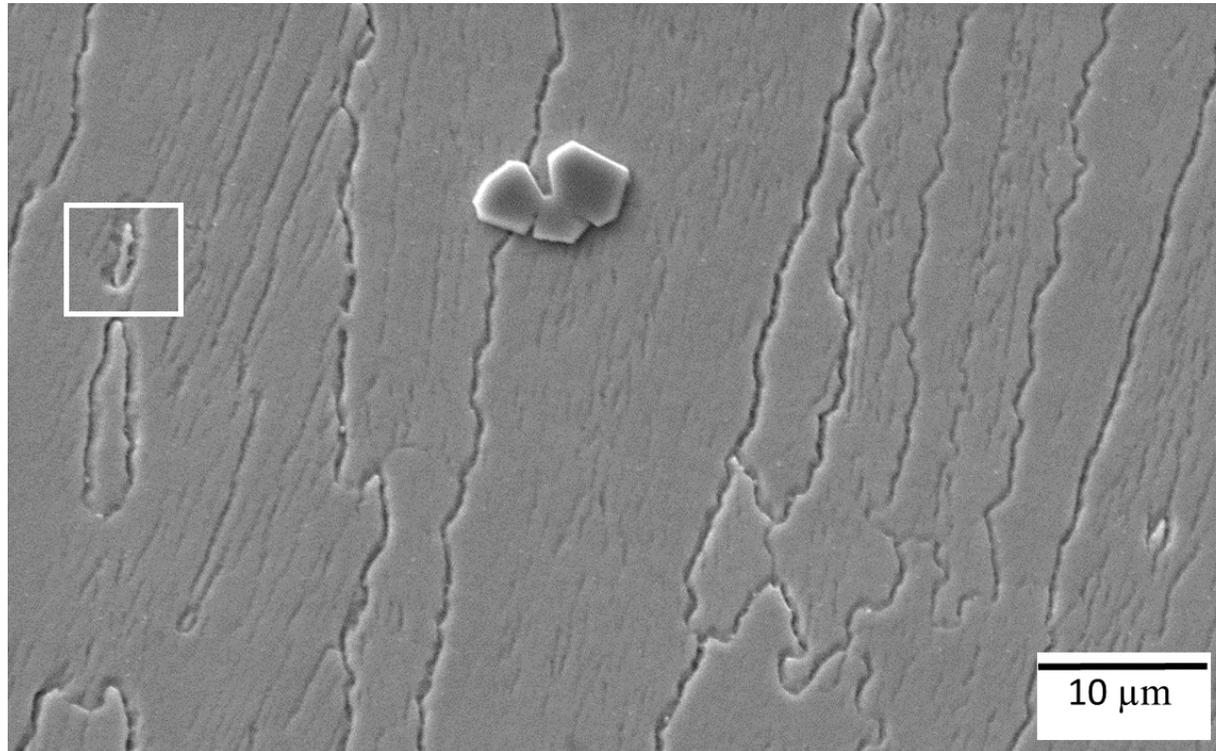
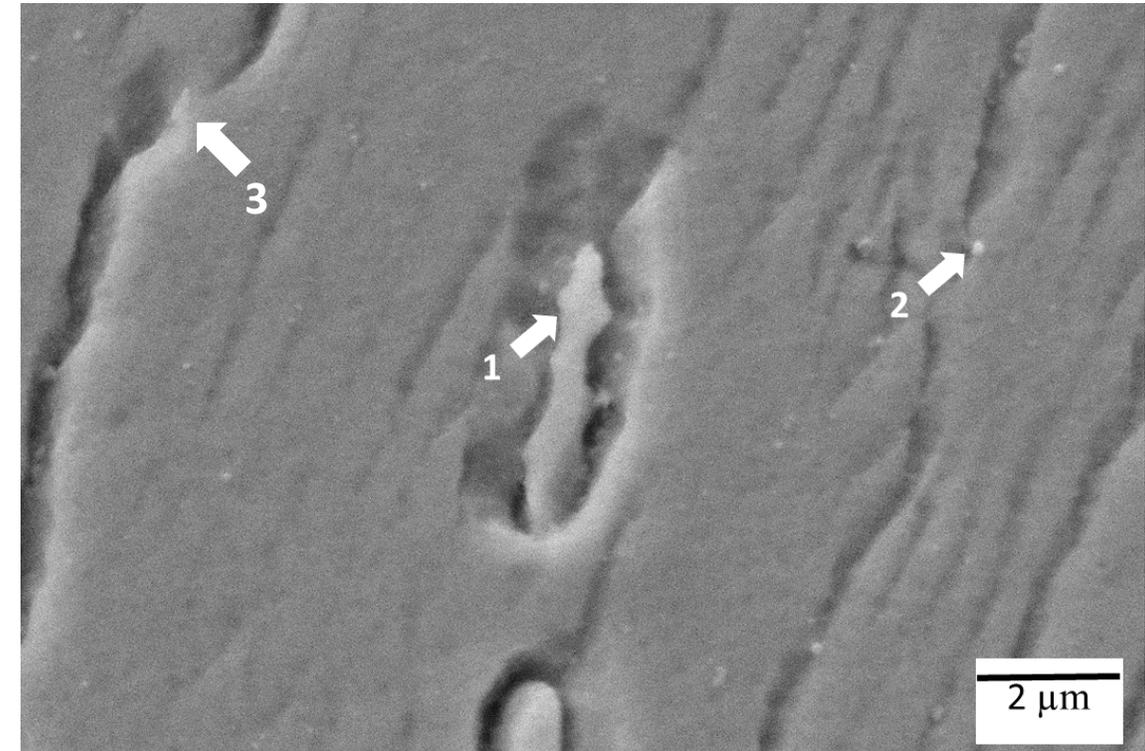
SLM Solution heat treated Base metal

(1) Remnants of Laves phase (2) MC-type carbide and (3) Delta phase in SHT condition

Solution heat treatment at 954°C - 1hr

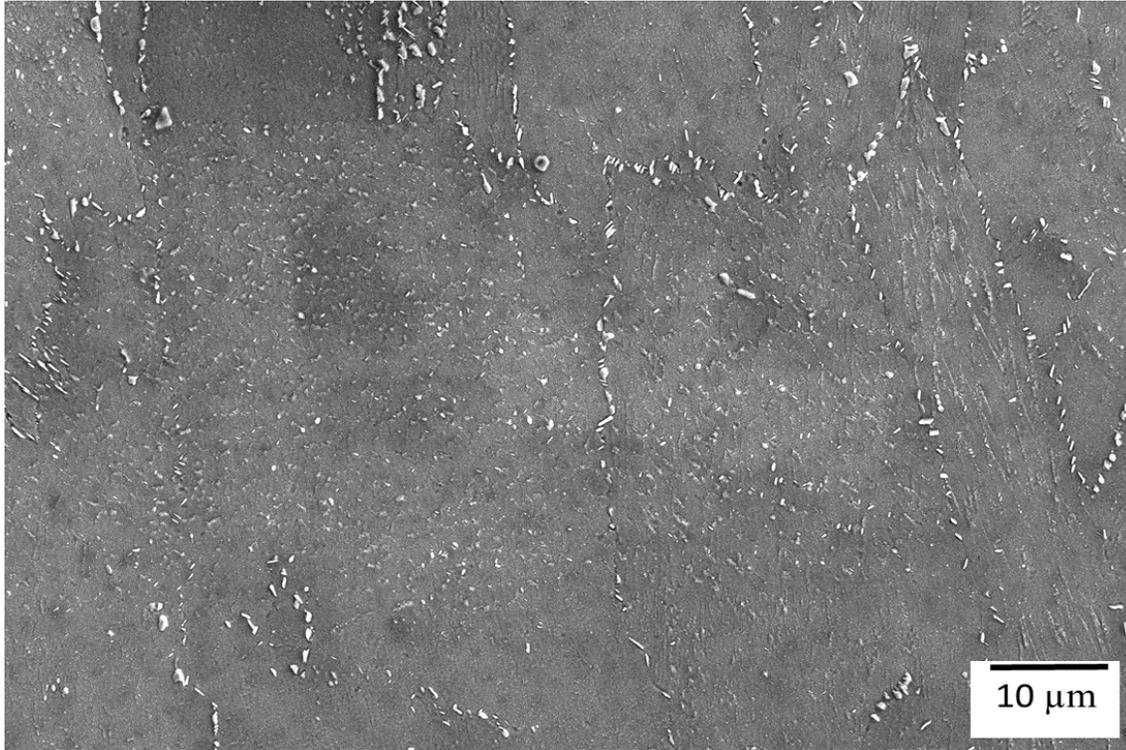
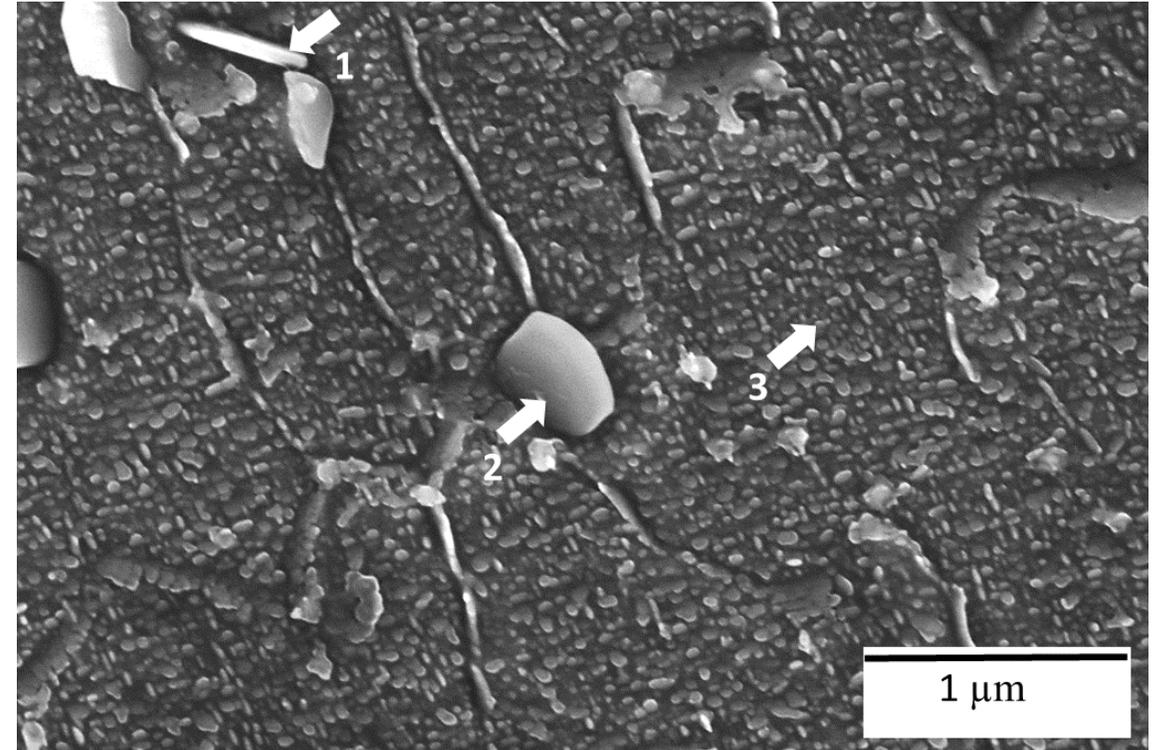
SLM Solution heat treated + Aged Base metal

Microstructure of SHT+AGE condition showing (1) delta phase, (2) MC-type carbide and (3) matrix with strengthening phases γ' and γ''

Solution heat treatment 954°C/ 1hr + Aging heat treatment 760°C/ 5hrs + 649°C/ 1

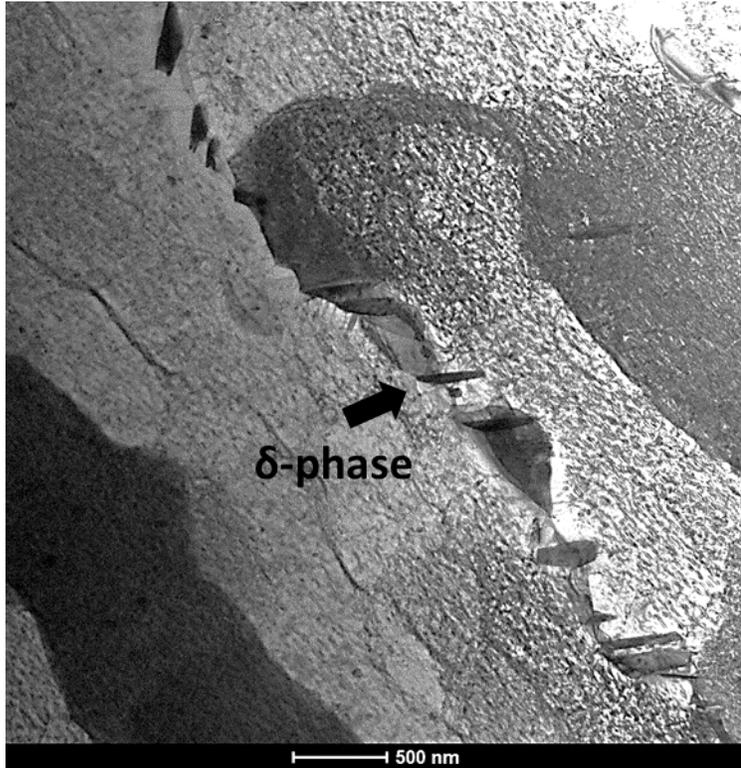
Delta phase pinning the grain boundary

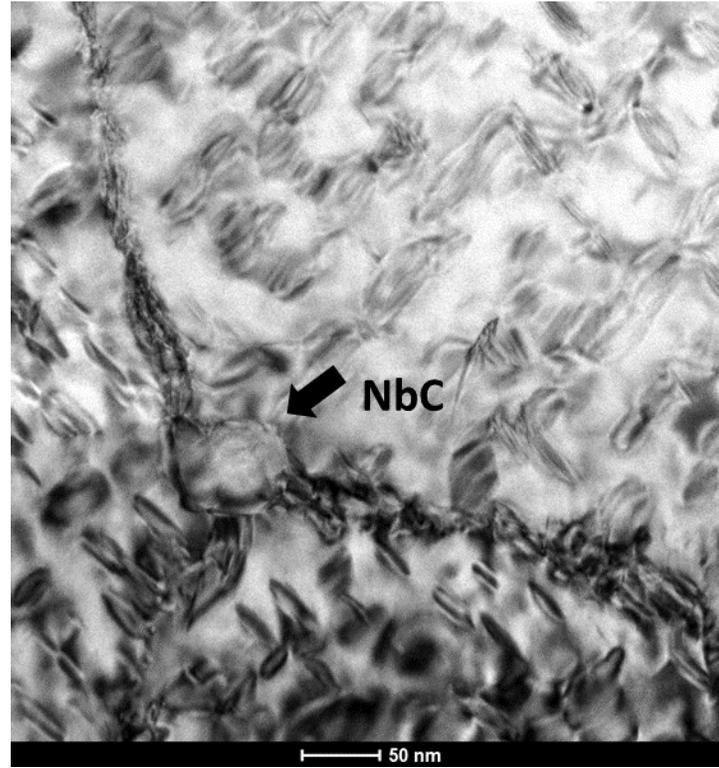
NbC carbide, γ' and γ''

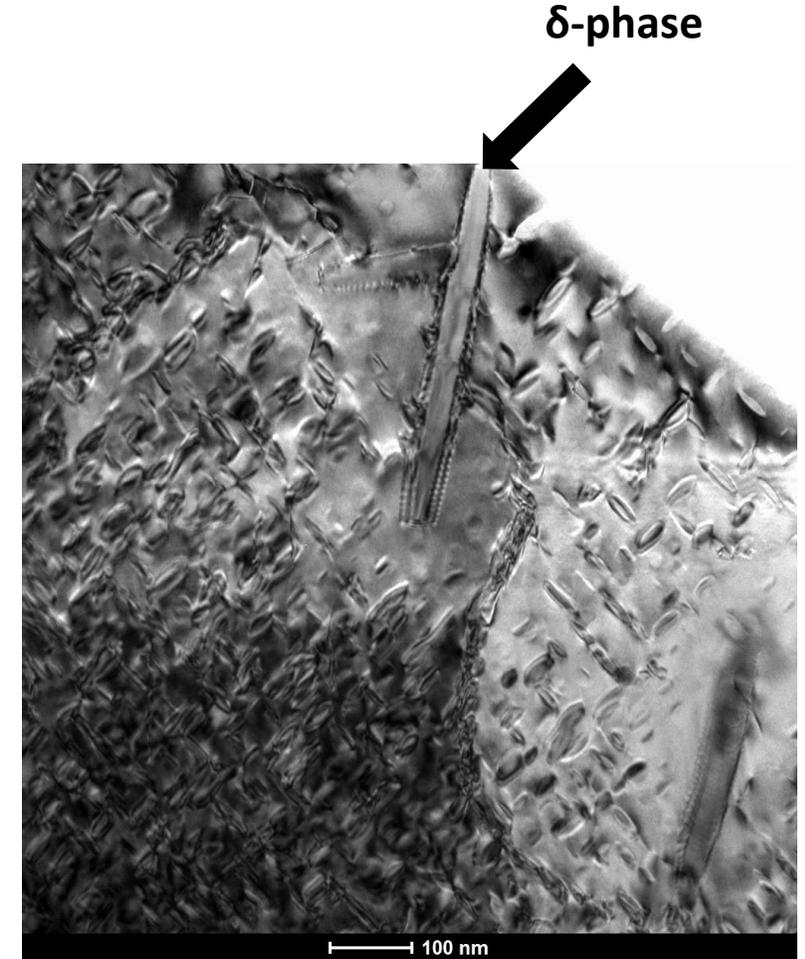
Delta phase, γ' and γ''

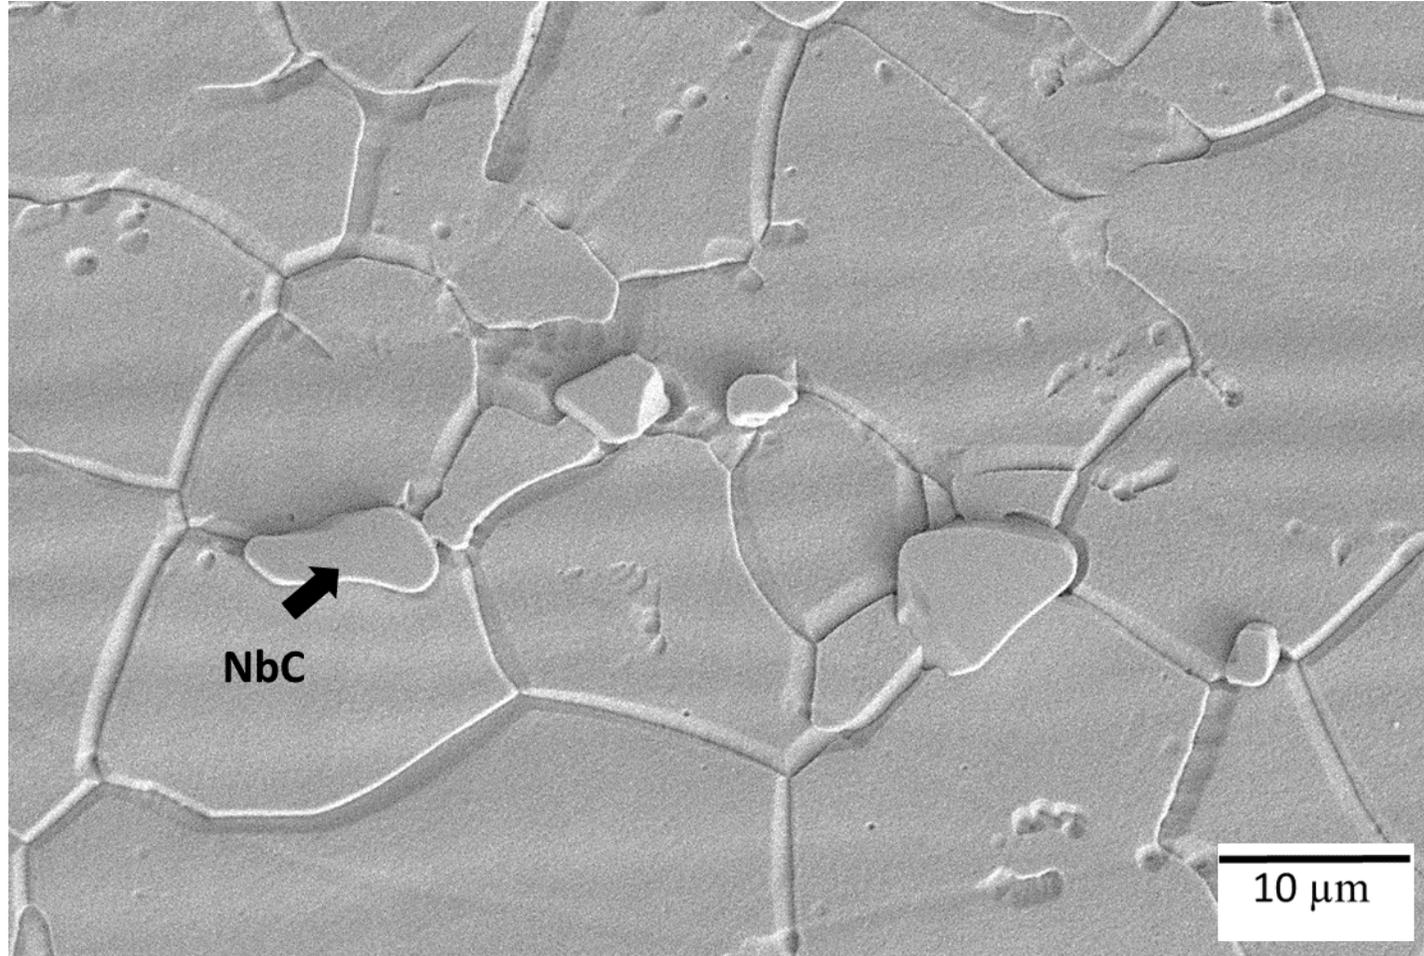
Wrought

Mill-annealed at 982°C - 4.5min

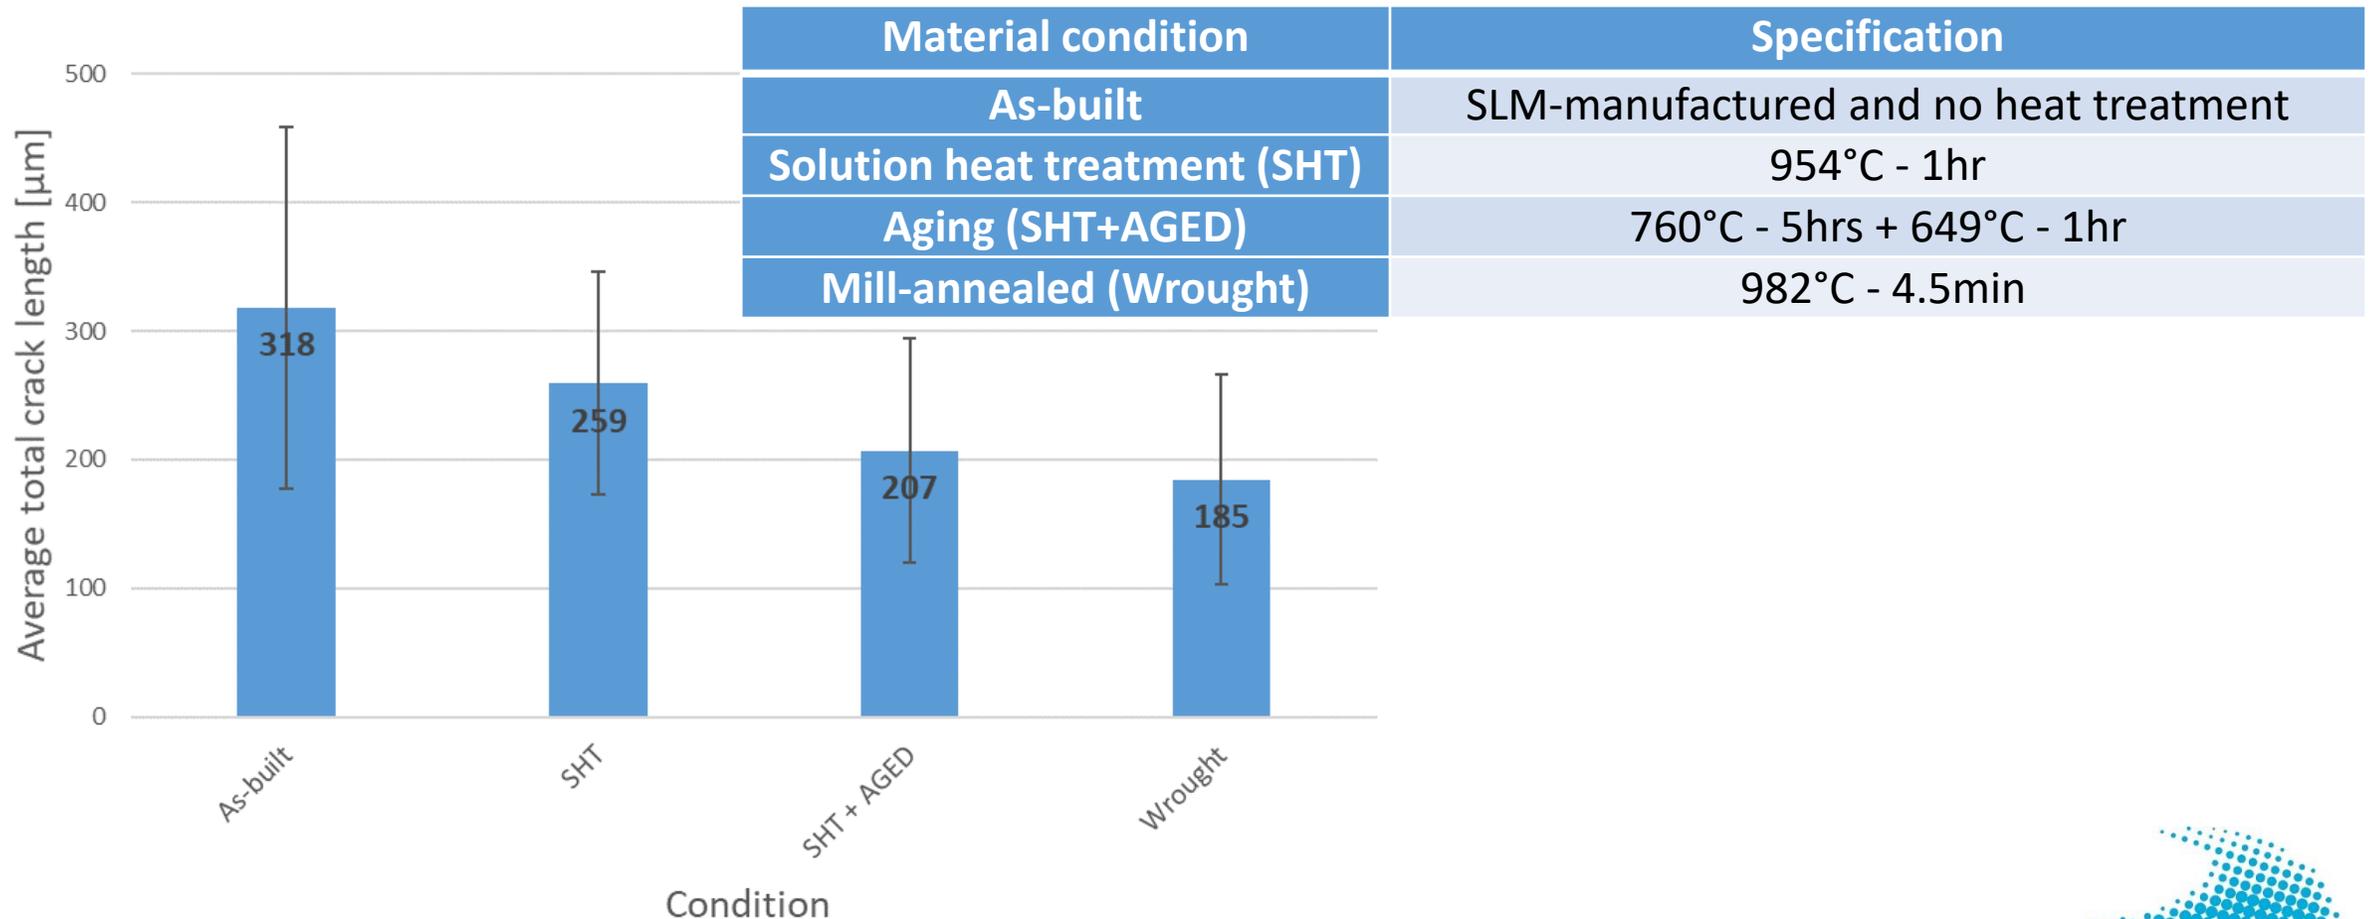
Total crack length measurements

Heat affected zone (HAZ) cracking susceptibility of SLM-manufactured Alloy 718

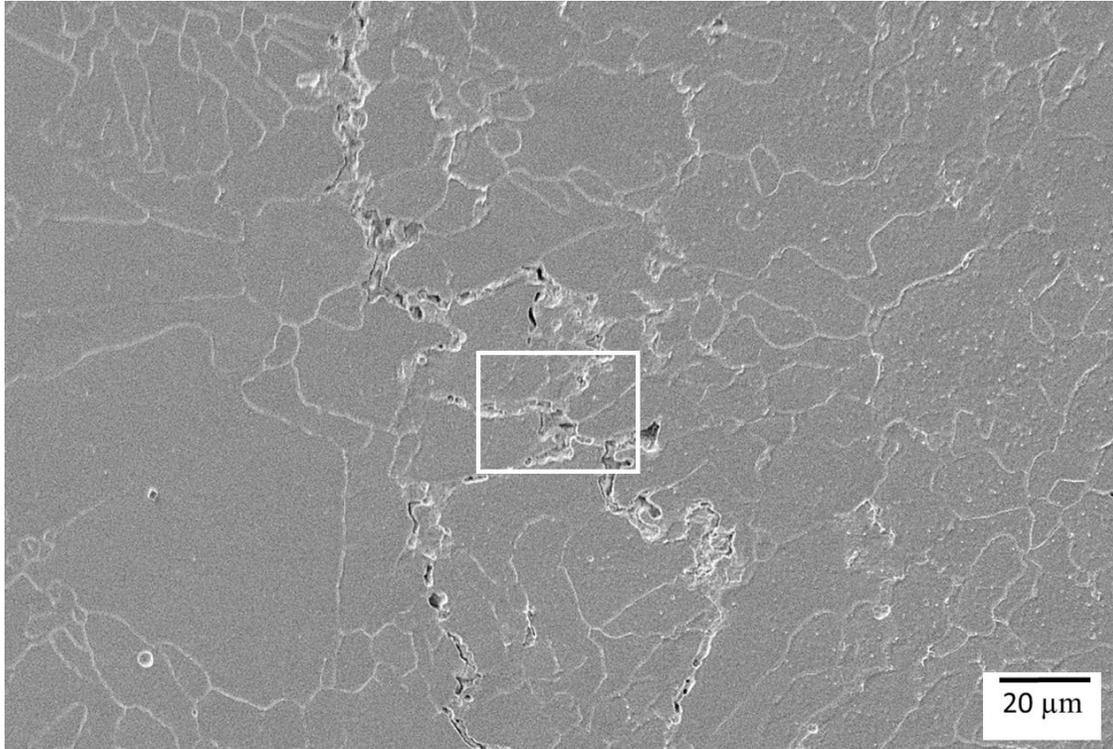
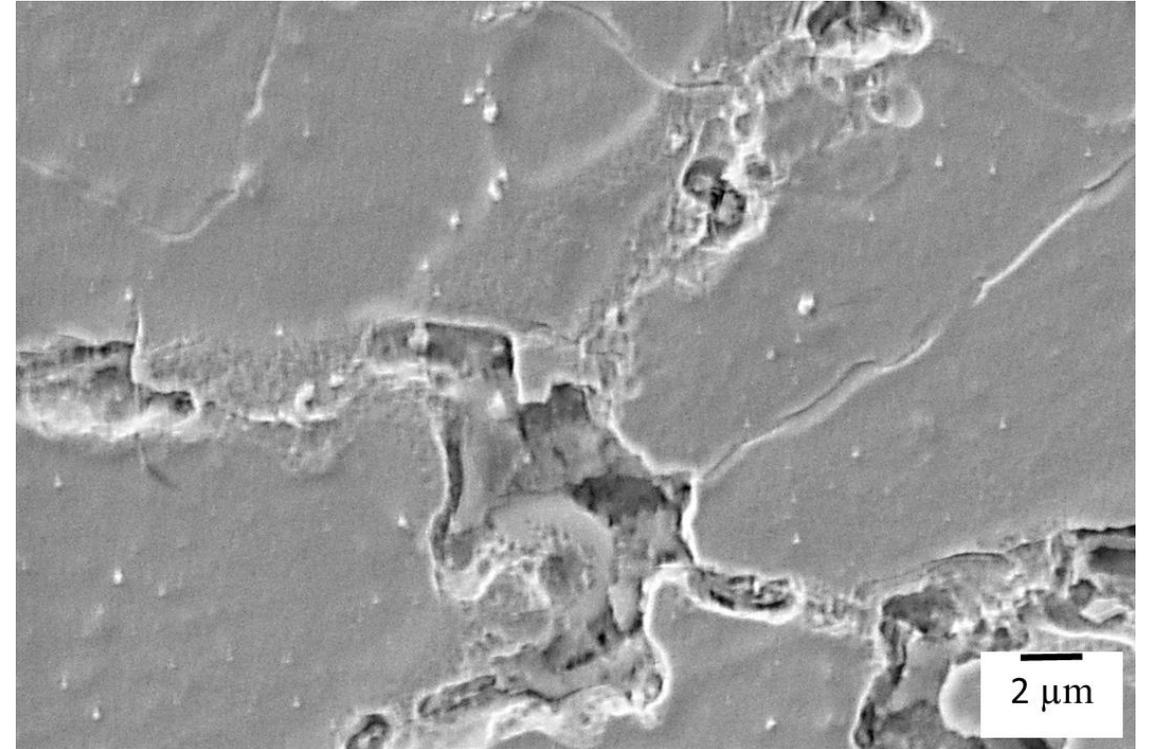
HAZ cracking in as-built condition

Cracking in as-built condition due to the liquation of Laves phase and carbide

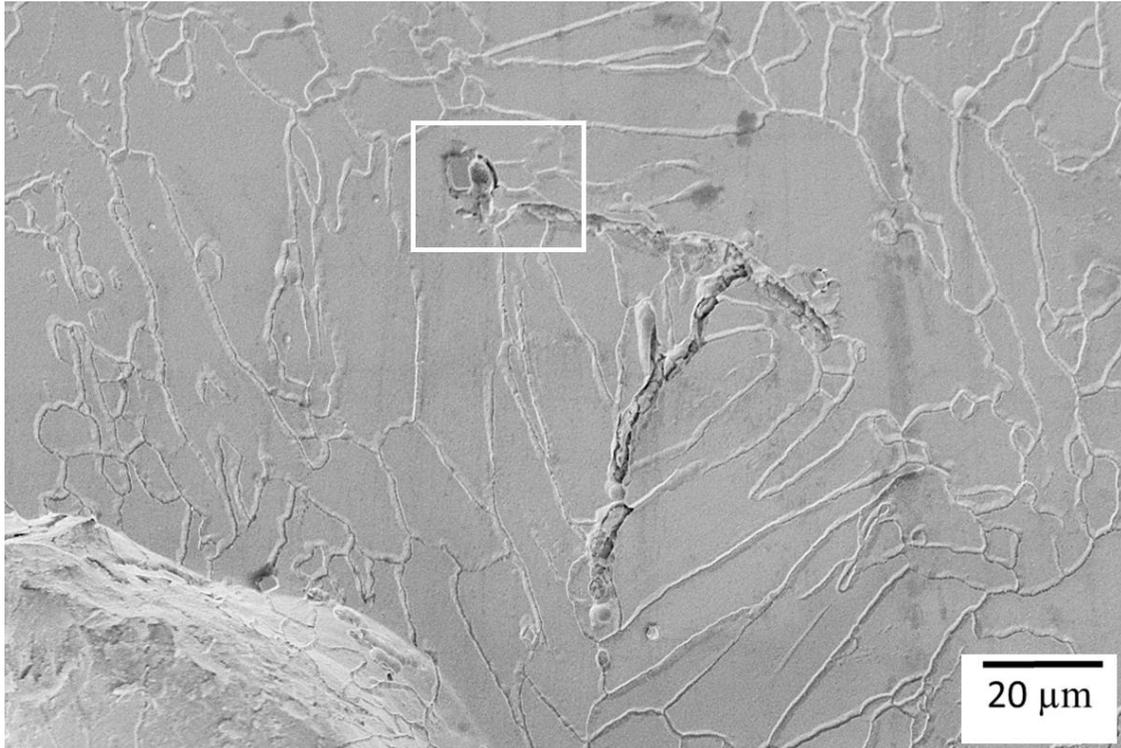
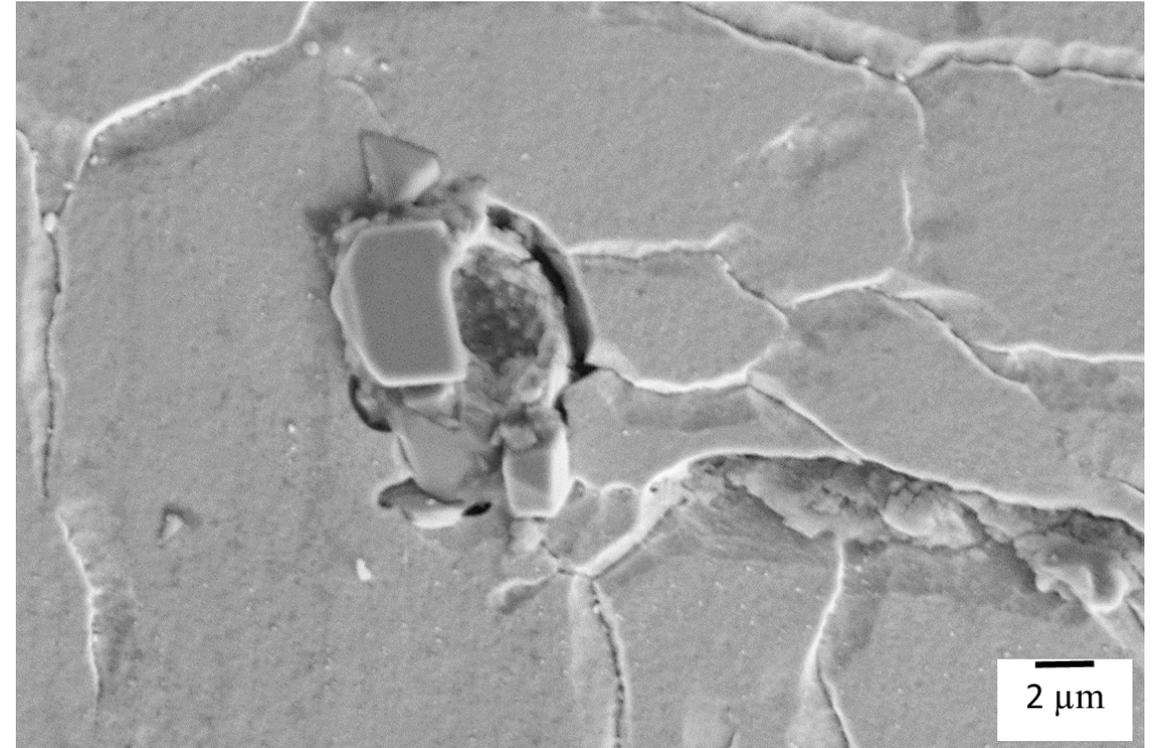
HAZ cracking in solution heat treated condition

Liquation of carbide and Laves phase causing intergranular cracks in SHT condition
