Selective laser melting of Alloy 718

Influence of heat treatments on heat affected zone cracking of selective laser melted and TIG-welded Alloy 718

PhD Student: Tahira Raza

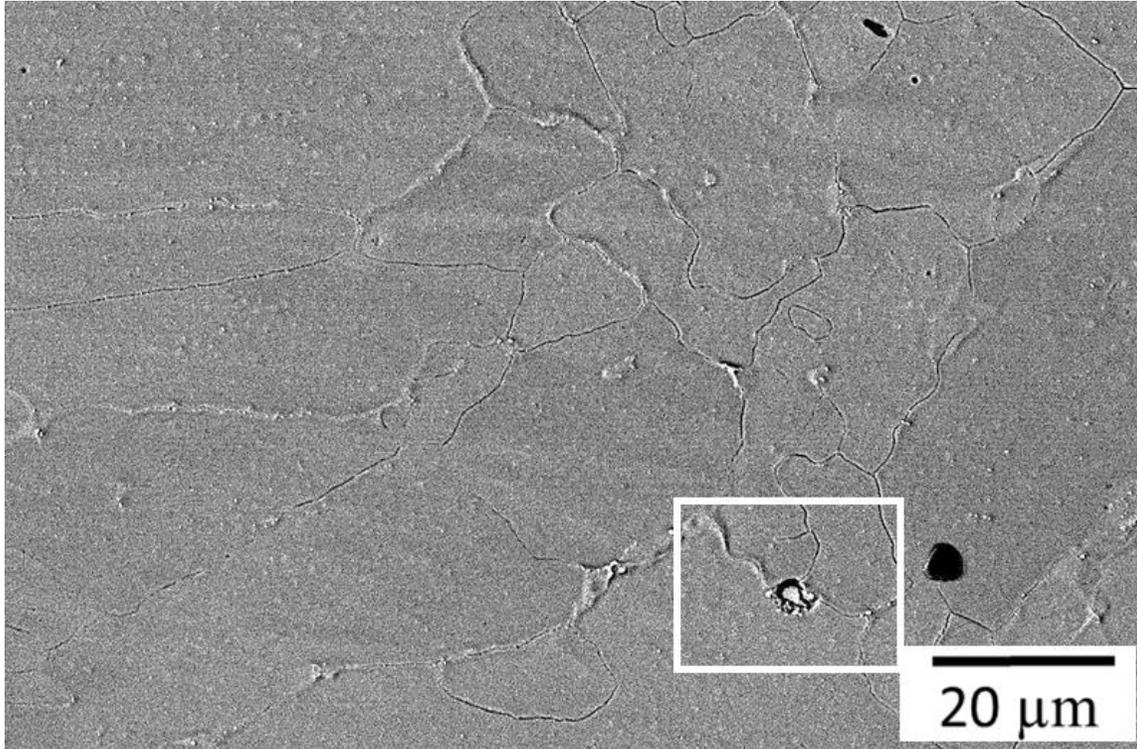
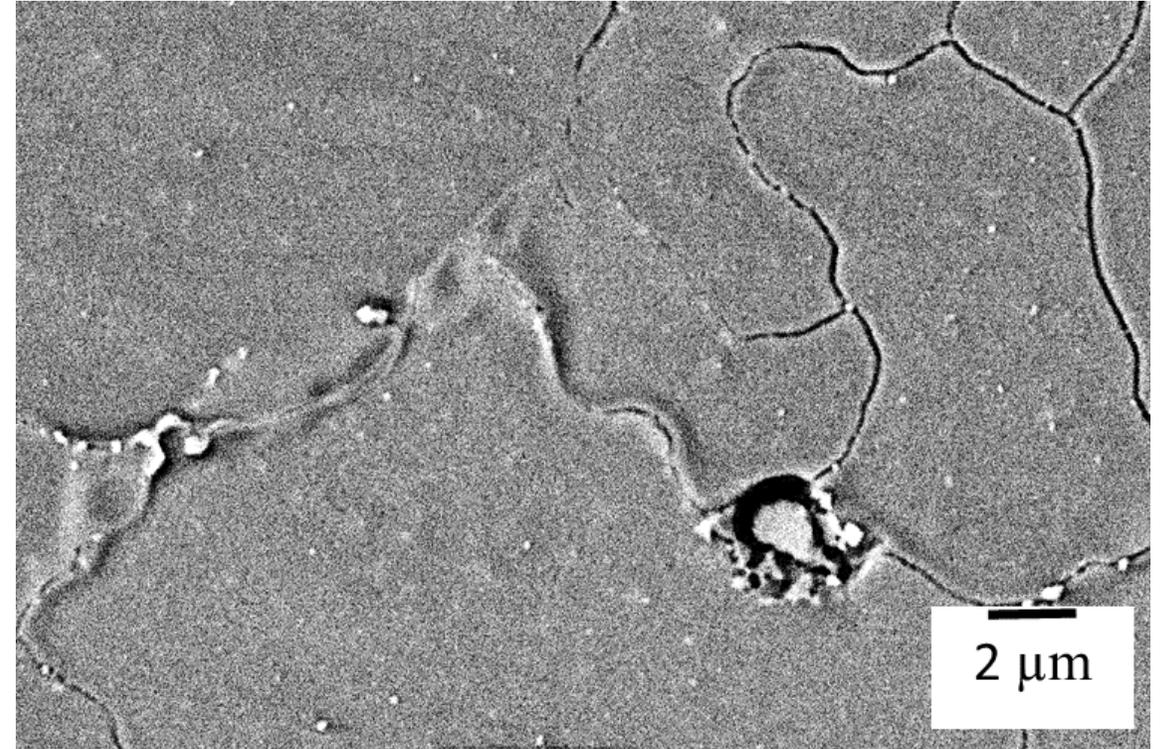
HAZ cracking in solution heat treated + aged condition

Liquation of carbides causing intergranular crack in HAZ of SHT+AGED condition

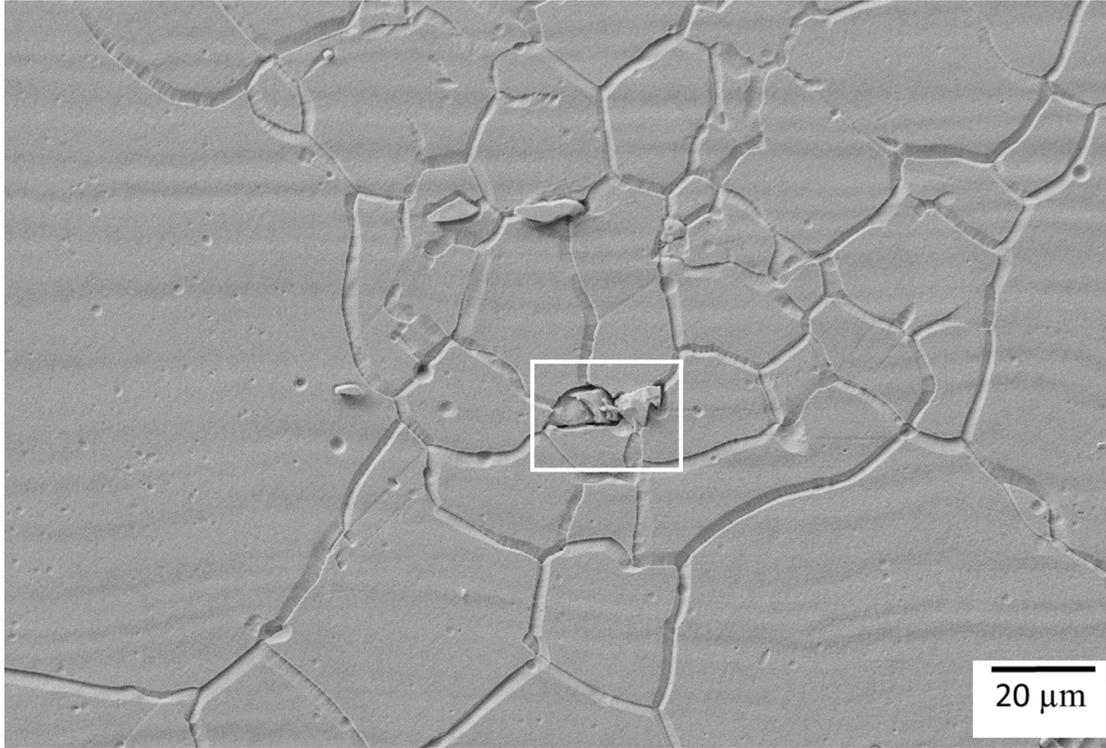
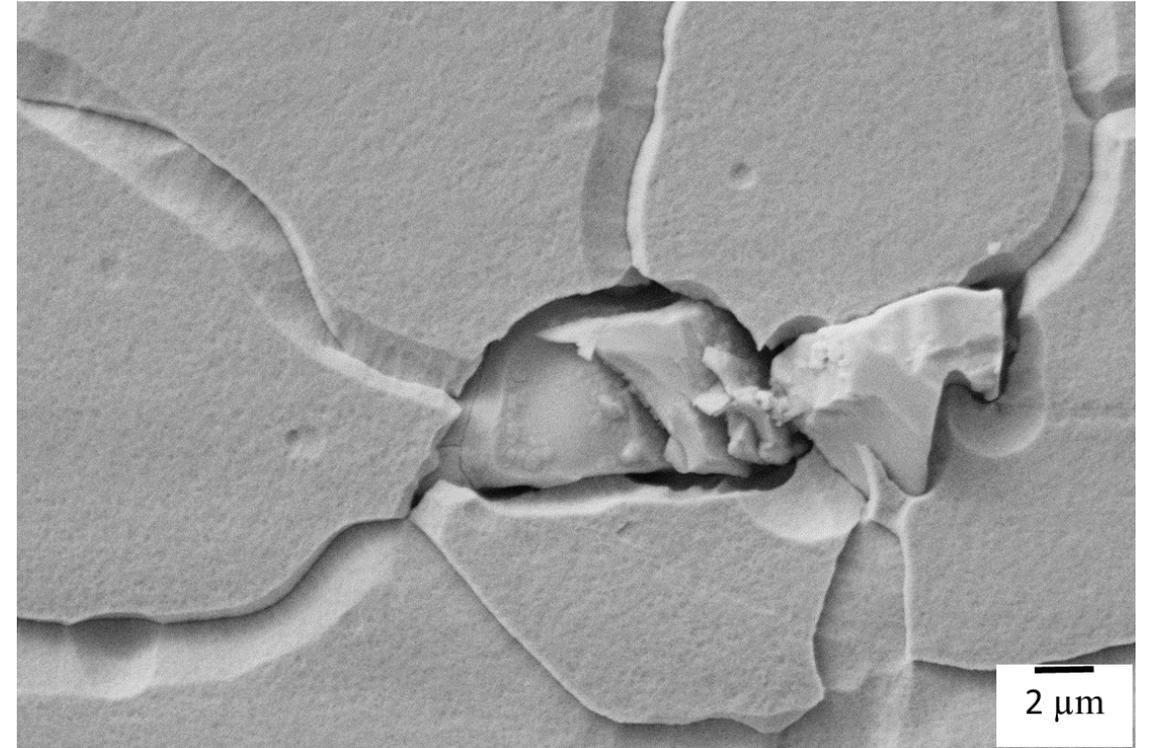
HAZ cracking in wrought Alloy 718

Liquation of carbides creating crack in HAZ of wrought Alloy 718

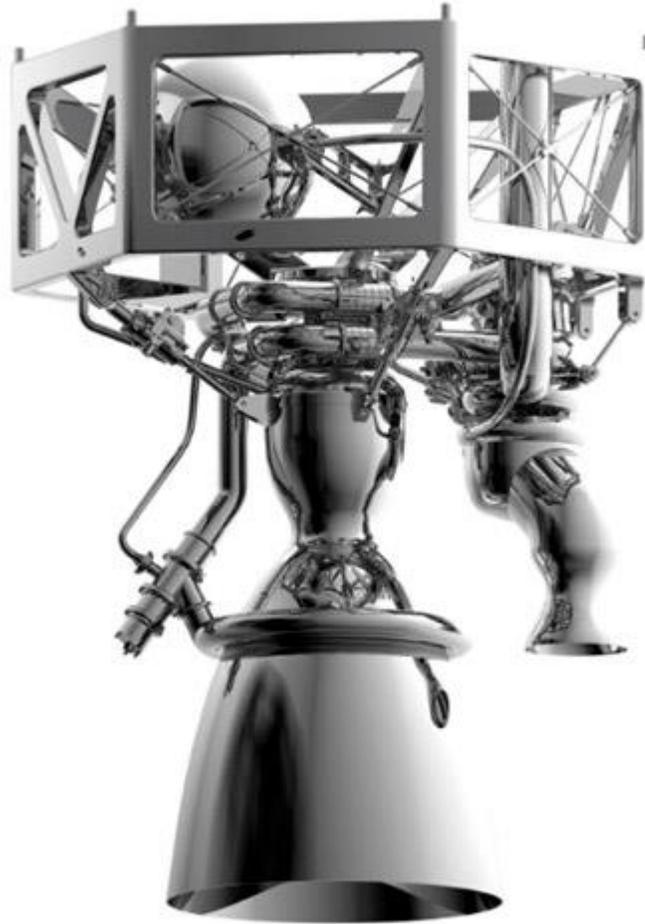
Prometheus, a low cost reusable rocket engine, using methane propellants

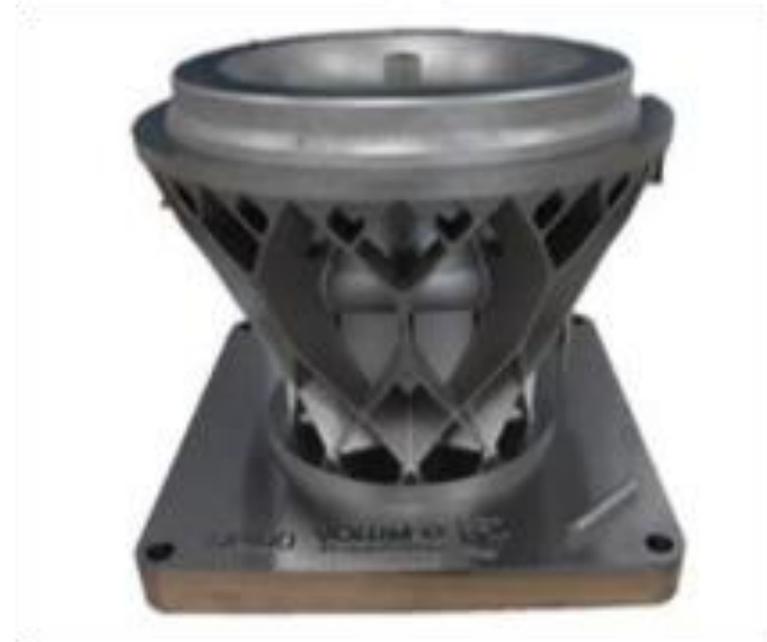
Prometheus casing prototype:
The Prometheus pump main casing is the biggest part produced with an M400 ALM machine
